**ALABAMA HAZARDOUS WASTES MANAGEMENT AND MINIMIZATION ACT (AHWMMA)**  
**Compliance Evaluation Inspection (CEI) Report**

United Plating – Stanwood Boulevard Facility (United Plating-Stanwood)  
3400 Stanwood Boulevard  
Huntsville, (Madison County), Alabama 35811

March 15, 2017

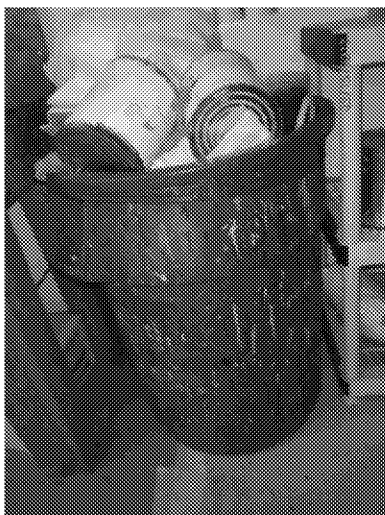
First, Mr. Butler escorted us to Building #2 that consists of a paint shop, two paint booths, a solvent reclamation still, and an adjacent satellite accumulation building. In this area, we observed two trash cans that contained discarded wet paint containers and another trash can that contained discarded wet paint filters from the paint booths (see Photographs #1 through #3). In this area we also observed a Chemchamp solvent still and a Herkules Automatic Paint Gun Washer (see Photograph #4). Next to the solvent still, we observed two 5-gallon containers of Spent/Lacquer Thinner to be recycled. The containers each had a lid, but the lids were not

- Three trash cans staged in Building #2 were observed containing wet paint containers and used paint filters;
- Two 5-gallon containers of Spent/Lacquer Thinner to be recycled were staged in Building #2 were not closed;
- One 5-gallon container staged in Building #1 was observed open and contained an unknown material;
- One 55-gallon satellite accumulation drum staged near the Boeing Research Line was not closed;
- Two 55-gallon drums of an unknown material was observed in the Shipping/Receiving Area of Building #1;
- One Super-sack of plating filters staged in the 90-day Hazardous Waste Storage Area was observed open;
- Two 8ft spent fluorescent lamps were staged in the Welding Shop Storage Area not in a

Photograph #1: Building #2: Trash can with discarded wet paint

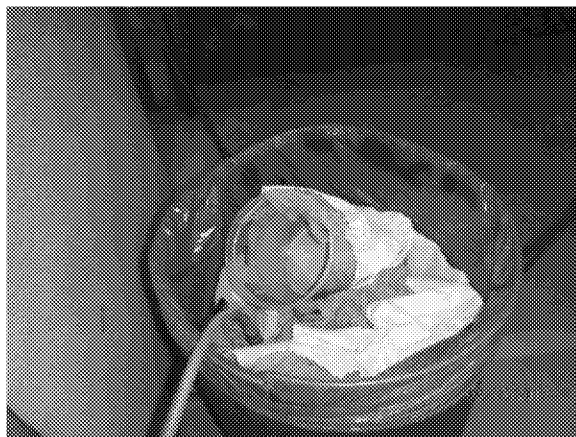
Photograph #2: Building #2: Trash can with discarded wet paint

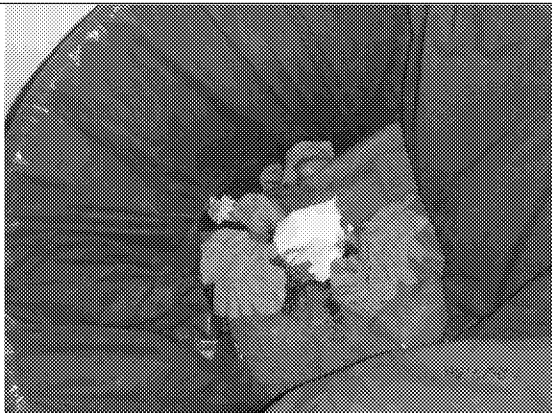
Photograph #3: Building #2: Trash can with discarded paint filter

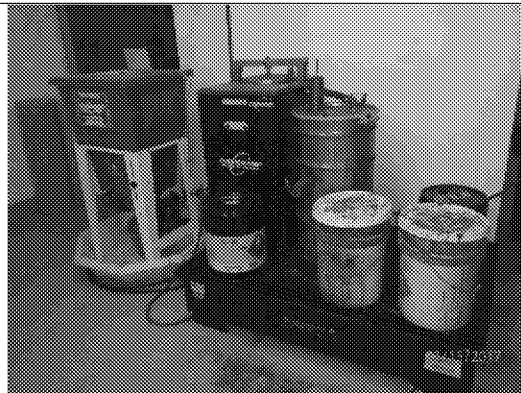
Photograph #4: Building #2: Waste solvent containers, solvent still, and paint gun washer

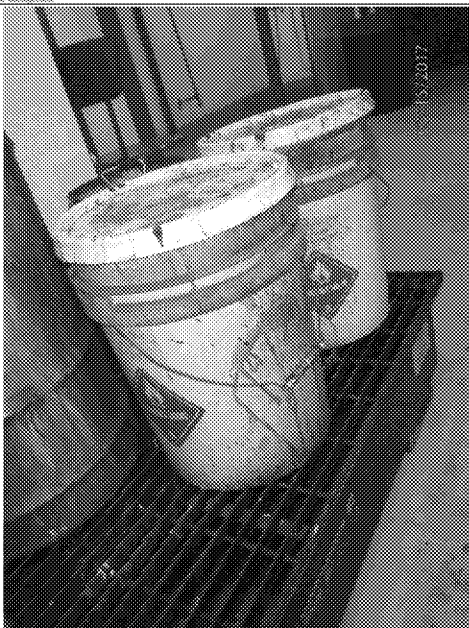
securely closed (see Photograph #5). Next, we were escorted to an adjacent building designated for the satellite accumulation point from the paint booth area. The building was locked and had signage bearing the words “Danger – Unauthorized Personnel Keep Out”. In this area, we observed one 55-gallon drum designated for solvent wipes and one 55-gallon drum designated for paint waste (see Photographs #6 and #7). The drum containing the solvent wipes was labeled with the words “Hazardous Waste”, closed, and marked with “D001, F003, and F005” hazardous waste codes.

Photograph #5: Building #2: Waste solvent containers

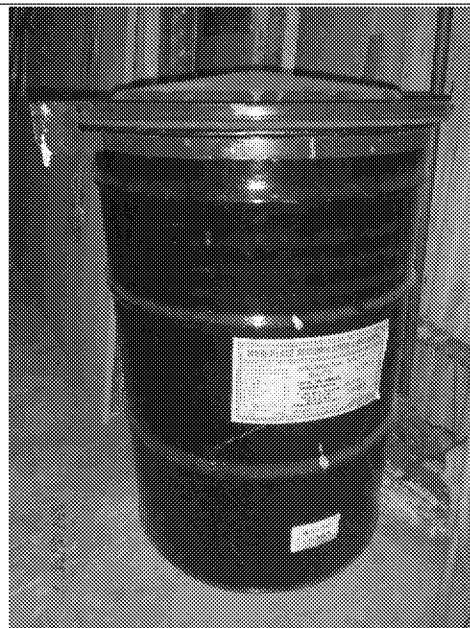
Photograph #6: Building #2: Satellite Accumulation Container for solvent wipes

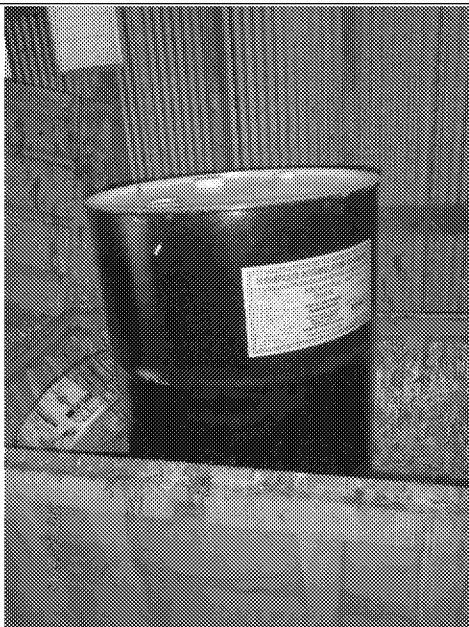
Photograph #7: Building #2: Satellite Accumulation Container for paint waste

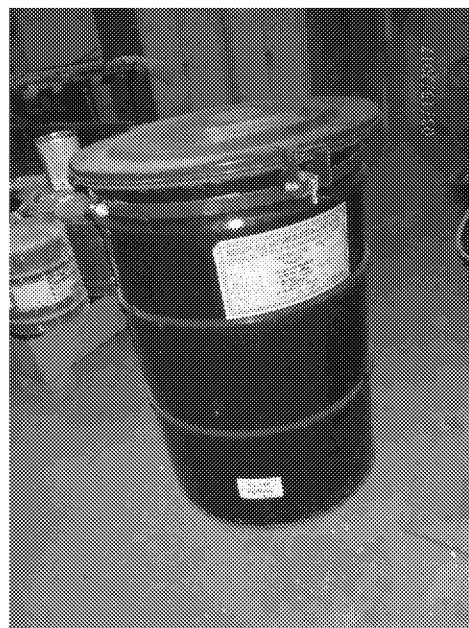
Photograph #8: Building #1: Satellite Accumulation Container for solvent wipes

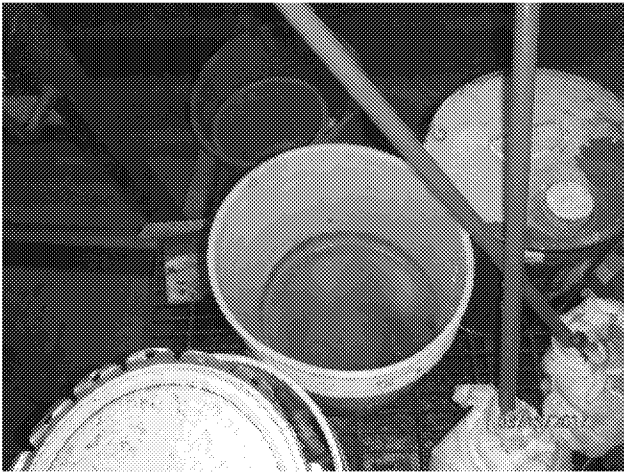
Photograph #9: Building #1: Container of unknown brown liquid

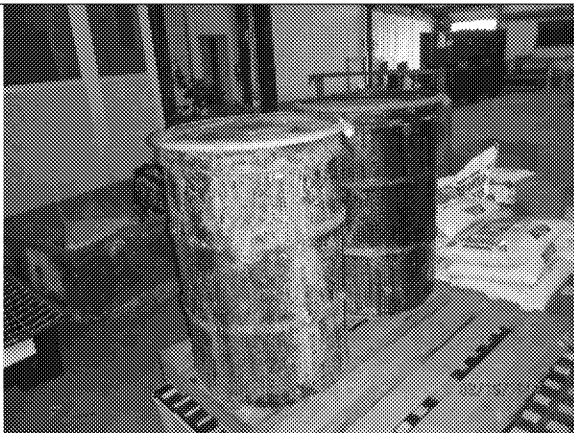
Next, we were escorted to the Shipping/Receiving Area of Building #1. In this area, we observed two 55-gallon drums of an unknown material (see Photograph #11). No other areas of concern were noted in the Shipping/Receiving Area.

Photograph #11: Building #1: Unknown drums staged in Shipping/Receiving Area

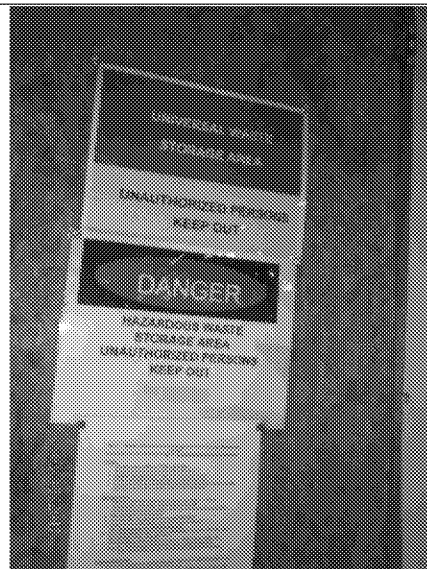
Next, we were escorted to the Universal Waste Storage Area located in Building #1. The universal waste storage area consists of a small storage shed with signage bearing the words “Universal Waste Storage Area – Unauthorized Persons Keep Out” (see Photograph #12). Inside the shed, we observed one 8ft cardboard box, one 4ft cardboard box, one small square cardboard box of used fluorescent bulbs, and one 1.25 gallon container of alkaline/nickel batteries (see Photograph #13). The 8ft box of used fluorescent lamps were marked with an accumulation start date of “9/8/16”, the 6ft box marked with an accumulation start date of “7/6/16”, and the small square cardboard box marked with an accumulation start date of “7/6/16”. The 1.25 gallon container of used batteries were marked with an accumulation start date of “5/23/16”. All of the boxes and the container were closed and labeled with the words “Universal Waste”. No areas of concern were noted in the universal waste storage area.

Photograph #12: Building #1: Universal Waste Storage Area

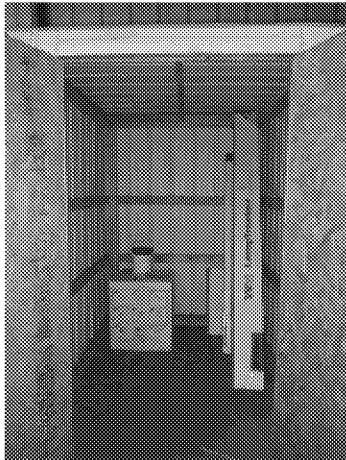
Photograph #13: Building #1: Universal Waste Storage Area

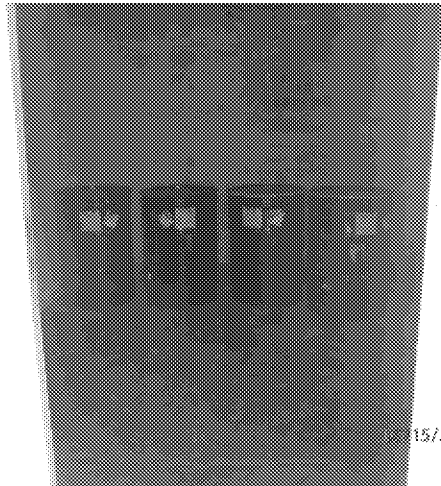
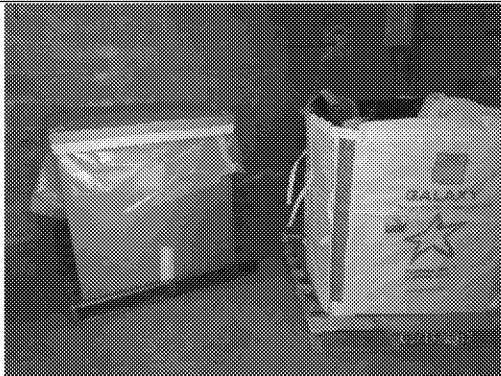
Next, Mr. Butler escorted us to the 90-Day Hazardous Waste Container Storage Area. In this area, we observed four 55-gallon drums of hazardous waste, one Gaylord box of paint filters, and one Super-sack of plating filters (see Photographs #14 and #15). Two of the 55-gallon drums were marked with "2/6/17" for an accumulation start date and hazardous waste codes "F006 and F019", closed, and labeled with the words "Hazardous Waste". The remaining two 55-gallon drums were marked with "3/7/17" for an accumulation start date and hazardous waste codes "F006 and F019", closed, and labeled with the words "Hazardous Waste". The Gaylord box containing paint filters was marked with "1/26/17" for an accumulation start date and hazardous waste codes "D001, F003, and F005", closed, and labeled with the words "Hazardous Waste". The Super-sack containing plating filters was marked with "1/4/17" for an accumulation start date and hazardous waste codes "D007 and D007" and labeled with the words "Hazardous Waste". The Super-sack was not closed in the 90-day Hazardous Waste Storage Area (see Photograph #16). The following items were present: a secondary containment system; appropriate signage alerting personnel to the possible presence of hazardous waste (e.g., "Hazardous Waste", "No Smoking", and "Danger – Unauthorized Personnel Keep Out"); spill response equipment; and a physical security system (e.g., locked doors) to minimize or prevent the unknowing or unauthorized entry of personnel into the area.

Photograph #14: 90-day Hazardous Waste Storage Area

Photograph #15: 90-day Hazardous Waste Storage Area

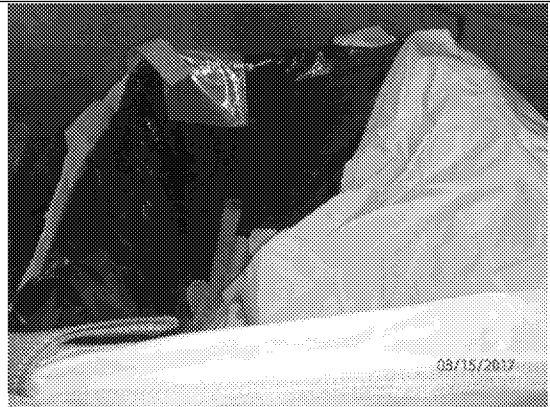
Photograph #16: 90-day Hazardous Waste Storage Area open super-sack

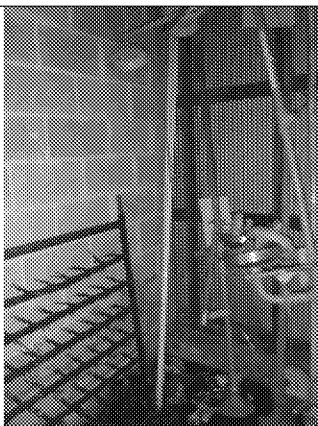
Last, Mr. Butler escorted us to the Welding Shop Storage area. In this area, we observed two 8ft spent fluorescent lamps staged in a corner not containerized, dated, or labeled (see Photograph #17). No other areas of concern were noted in the Welding Shop Storage.

- contained, dated, or labeled;
- Weekly inspections of the hazardous waste storage area were not conducted from 1/3/17 to 1/23/17;
  - No annual hazardous waste management training was conducted for the required staff in 2016; and
  - Waste Minimization Plan needs to be updated to include current process lines and manifest logs.

Photograph #17: Welding Supply Storage Area: Two universal waste lamps not contained, dated, or labeled
